Automated mapping of hurricane roof damage using deep learning and drone imagery: An end-to-end Esri ArcGIS Pro workflow

Maja Kucharczyk, PhD Candidate, University of Calgary

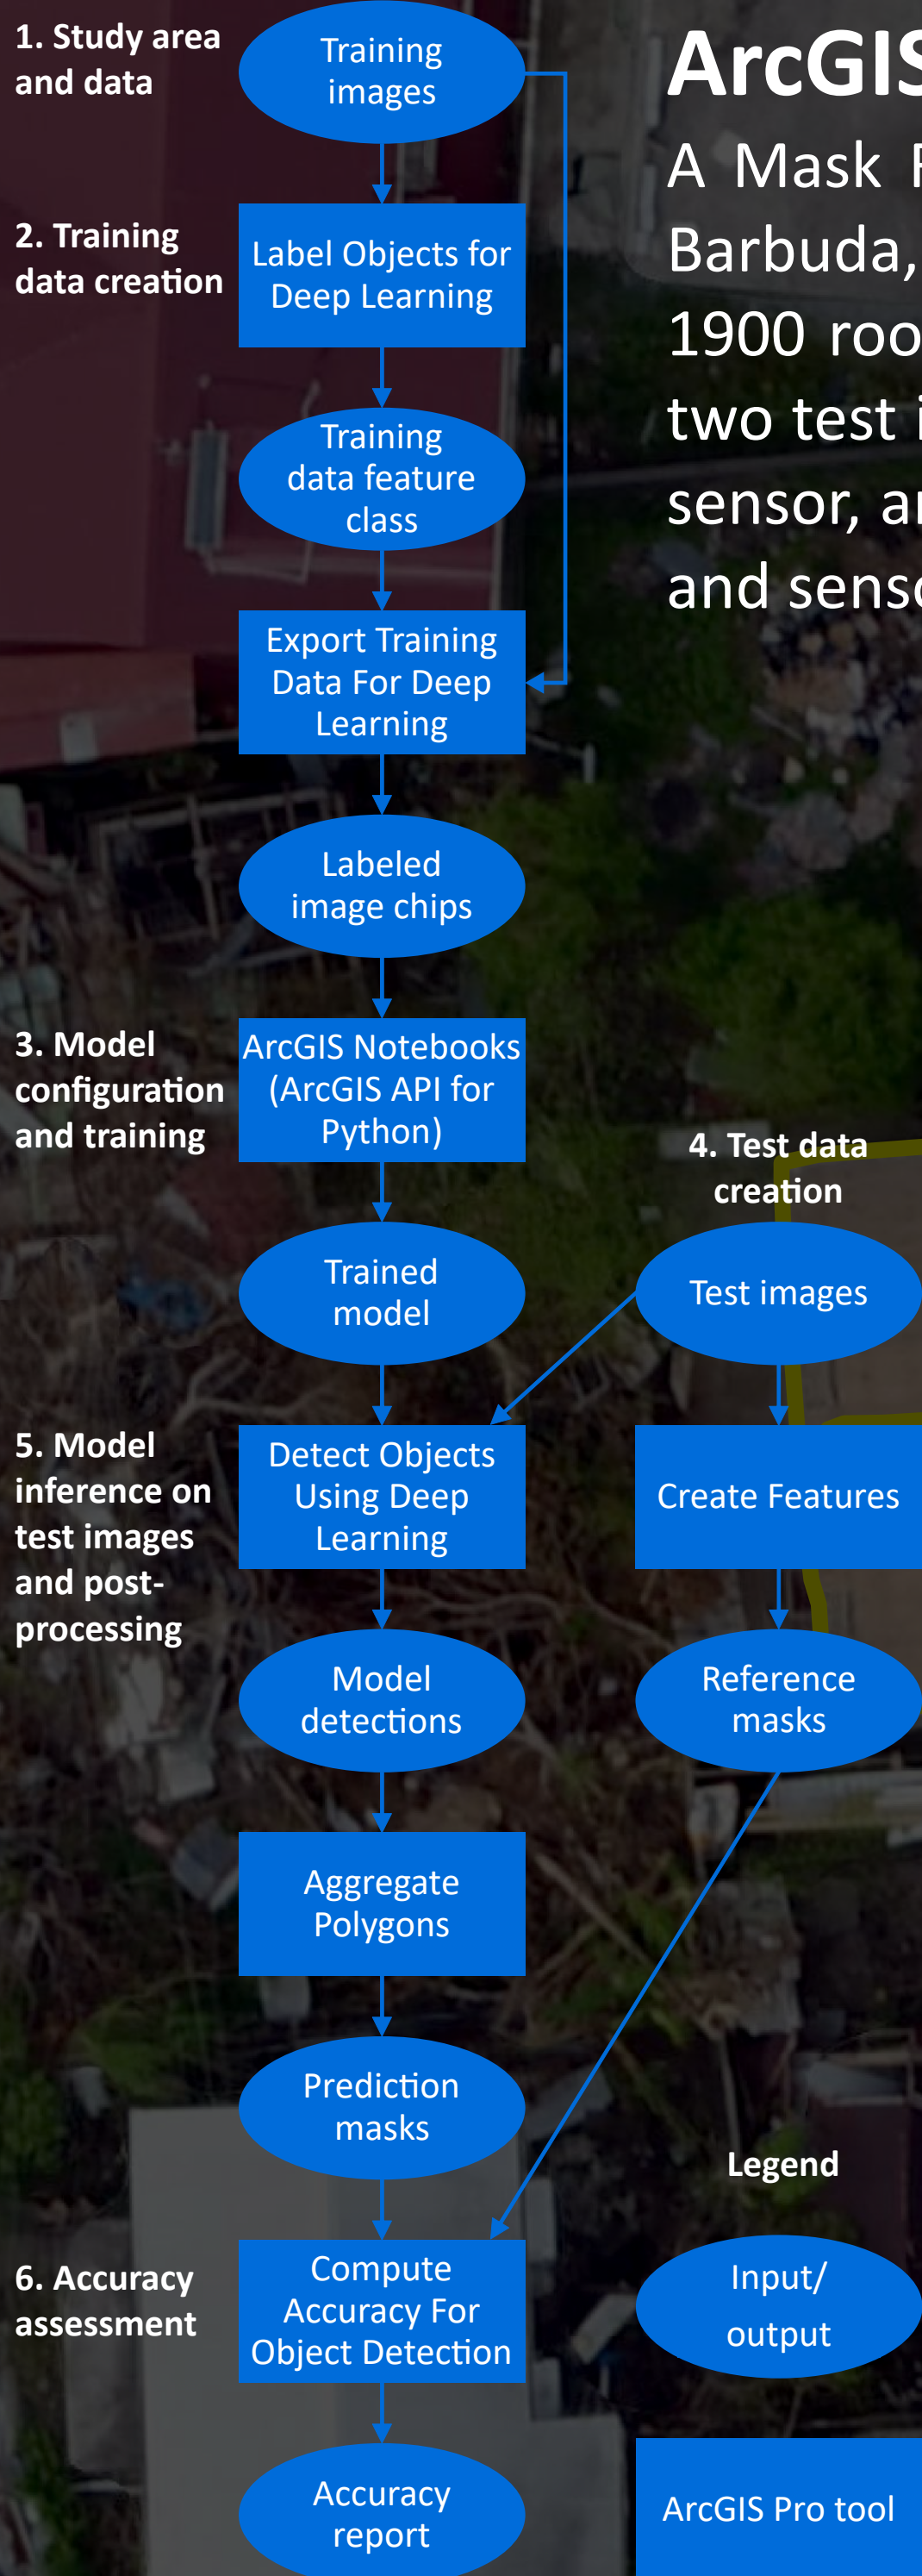
Figure 2. Workflow showing inputs/outputs (ovals) and ArcGIS Pro tools (rectangles).

A Mask R-CNN model was trained (Fig. 2) using drone orthomosaics captured in Sint Maarten, Antigua and Barbuda, and Dominica following Hurricanes Irma and Maria in 2017. Training data were created by digitizing 1900 roof decking objects and 1300 roof hole objects (Fig. 3). The trained model was evaluated (Fig. 2) using two test images: one captured within the general training area in Sint Maarten by the same drone platform and sensor, and another captured outside the training area in the United States Virgin Islands with a crewed aircraft and sensor that were not used during training.

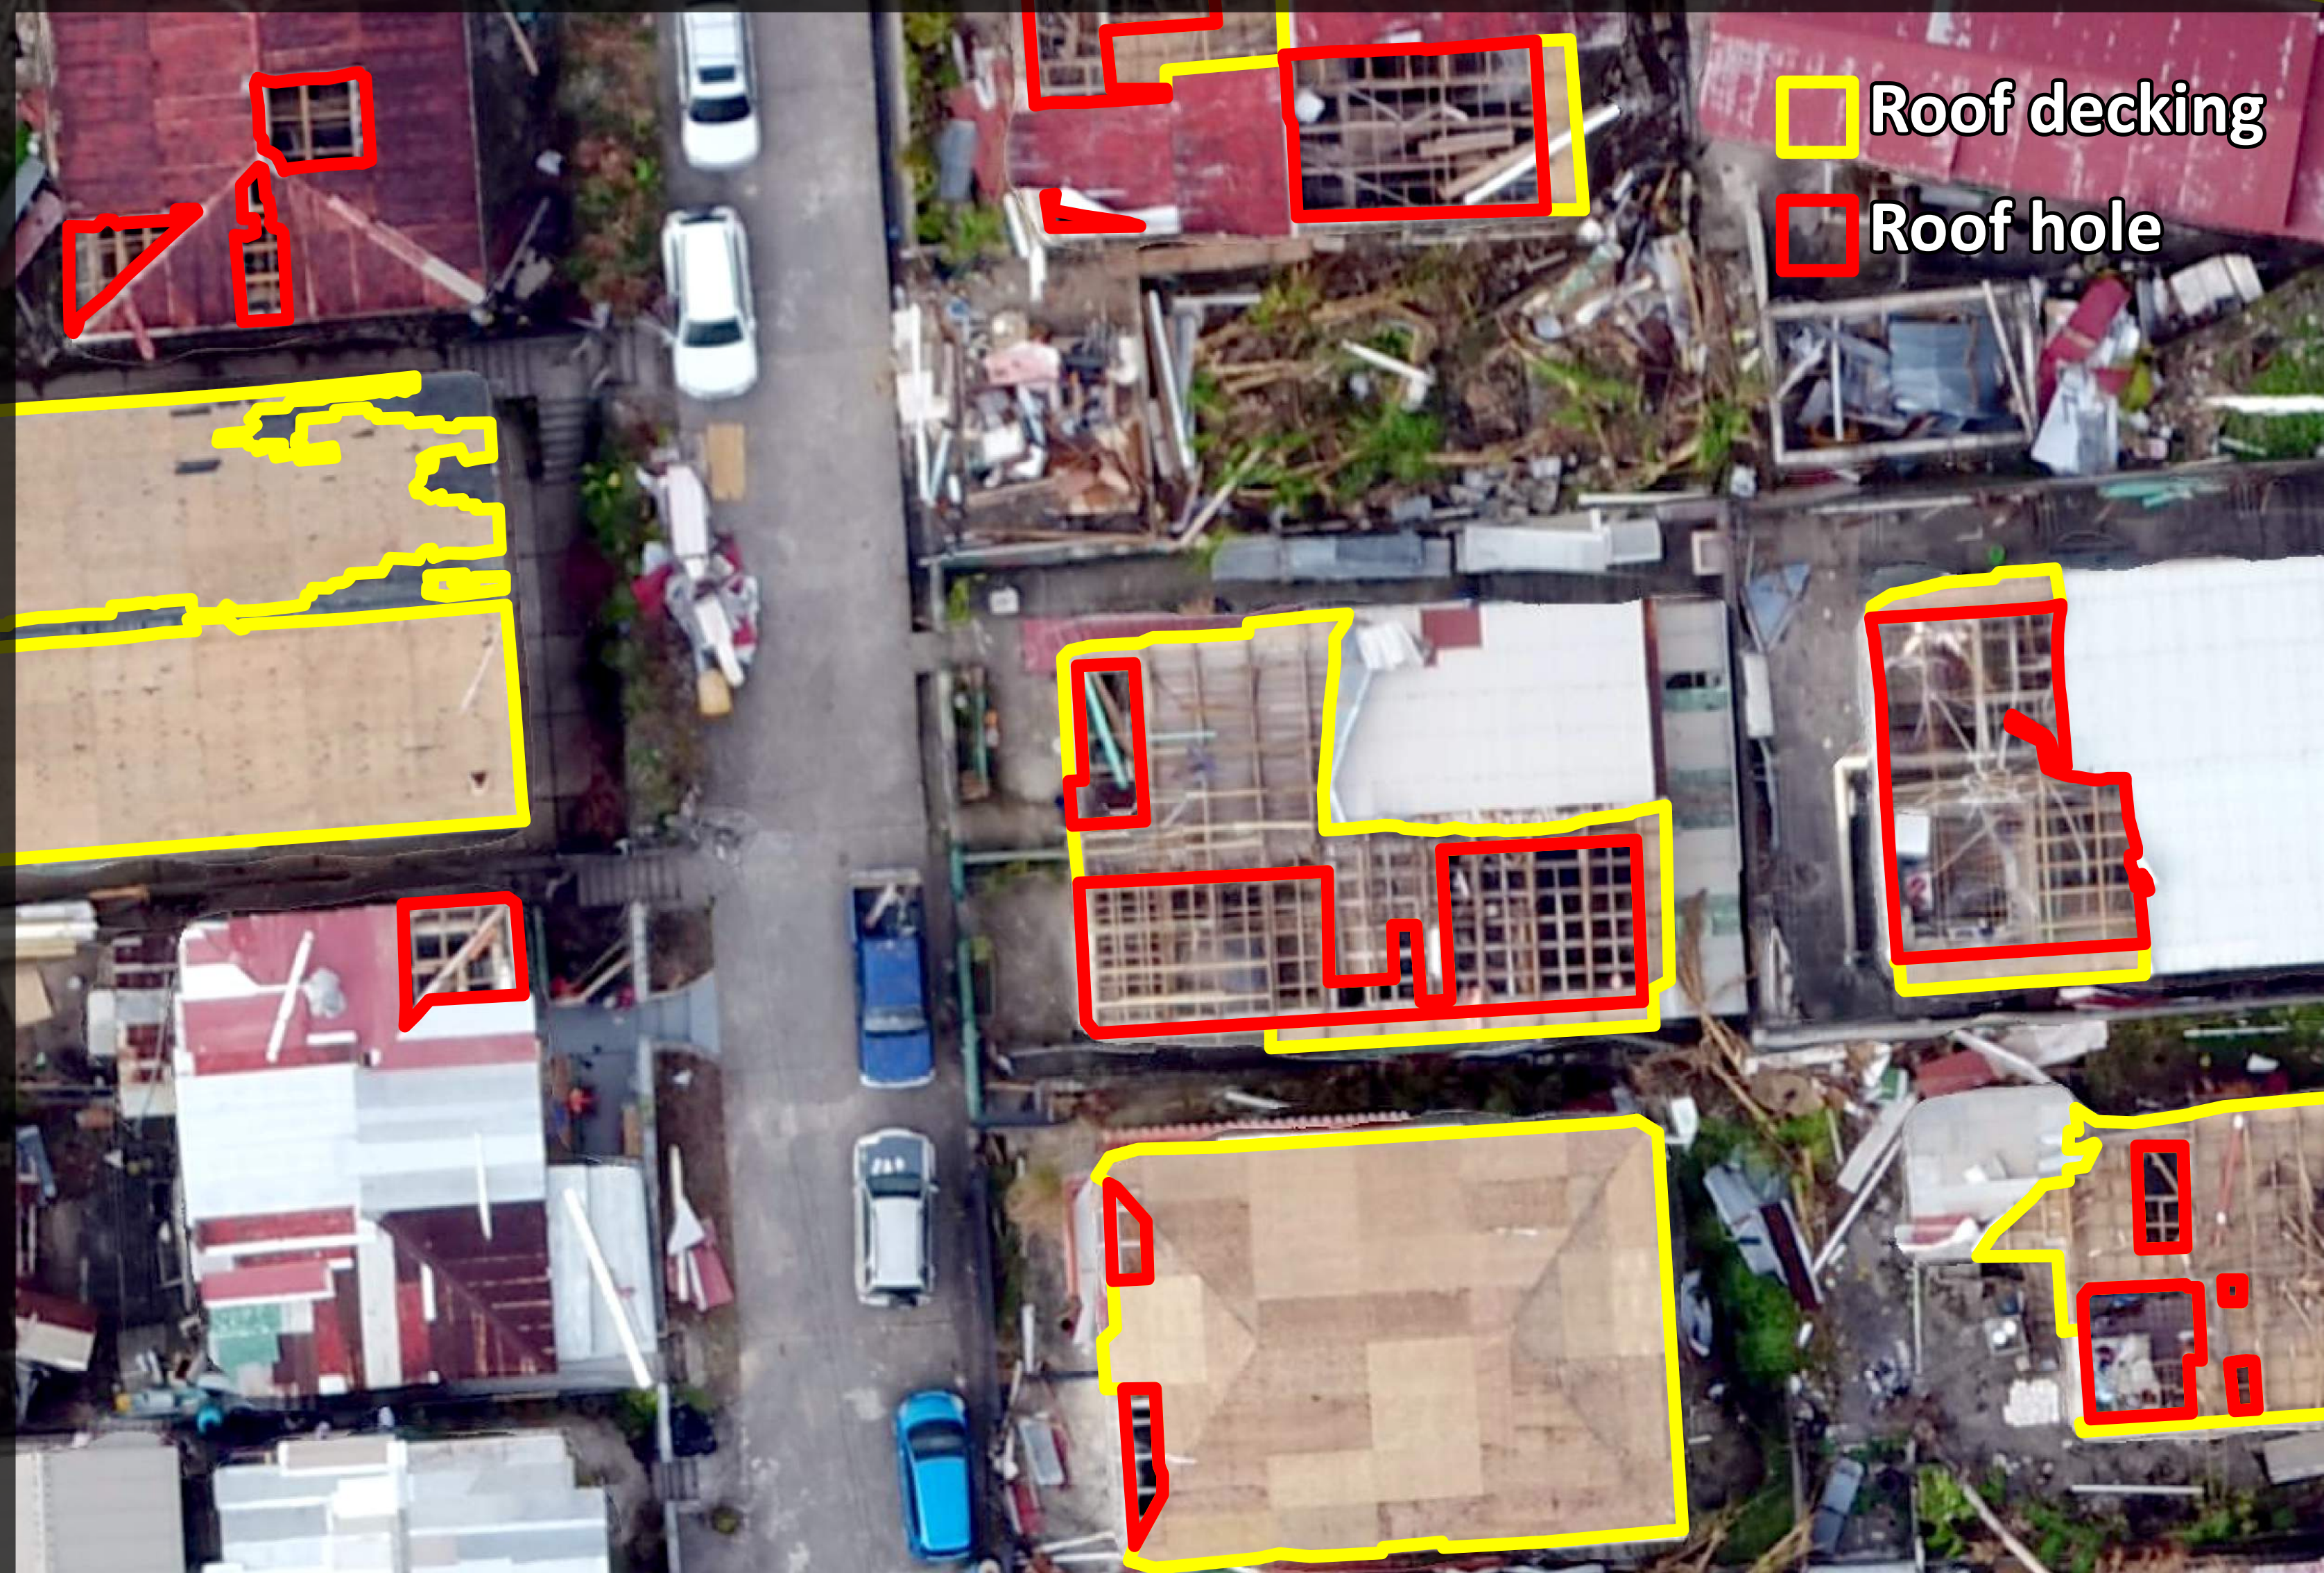
Figure 3. Examples of training samples delineating roof decking (yellow polygons) and roof holes (red polygons). Image: GlobalMedic (2022)
